Preliminary Architectural Feasibility Report
Barn Renovation at Rose Haven Center of Healing

Robert Greene Sands, PhD
CEO
Pamlico Rose Institute

Partial Fulfillment of Requirements for a Rural Development Grant

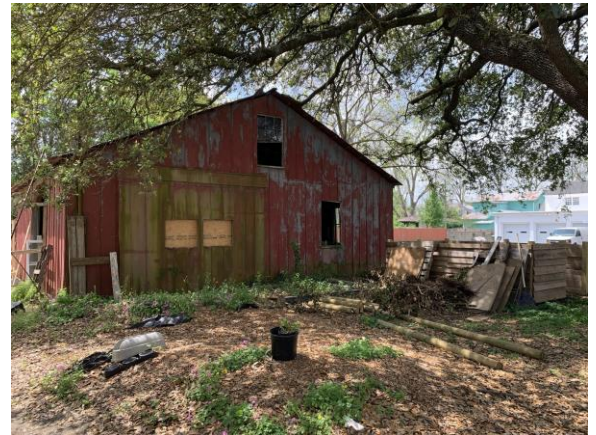
The barn was constructed in 1961 by a blacksmith, with help from the local community, replacing an original barn built in 1934 destroyed in a fire. It is a simple pole barn design and the exterior has undergone little, if any modifications, retaining the original tin outer skin and tin roof. The barn is not a historic structure but is a contributing element of the historic property at 219 E. 3rd. In past and recent conversations with John Wood of the North Carolina State Historic Preservation Office, as well as selected members of the Washington Historic Commission, the prevailing sentiment is to see the barn renovated instead of demolished.

Current Condition (see Appendix A for the architectural report)

Presently, the wood framing is in need of some attention to stabilize it and minimize future rot and damage from weather, termites, etc. The floor of the barn is dirt with a sill plate set atop wood piles. More specifically, the barn sits on a series of wooden footers, half of which show termite damage from the past and are compromised, and finally the floor is dirt and unlevel. A footing has been dug out around the perimeter of the barn in preparation to lay a concrete floor. Both tin roof and exterior skin are relatively intact with the roof compromised on the south end due to a large hole and other smaller holes along the length of the roof. Considering these faults, the roof is fairly water-resistant. The outer skin is also compromised, from inside the structure, daylight is visible in many locations through the siding and roofing, with small openings likely caused by weathering. A structural report by RPA Engineering shows recommended repairs, and a detail for how to add a concrete slab to the existing structure. Most of the windows have wood sashes that have fallen apart, leaving the space largely open to the elements. The existing barn doors and openings require some rebuilding to render them operable, but they add to the charm of the structure. Before much else

- Lay a concrete footer and then level and pour and seal a concrete pad to cover the entire interior sq footage
- Repair the south ¼ of the tin roof or purchase a new tin roof

- Repair outer skin with existing tin surplus
- Rebuild wooden door frames and rebuild/restore windows with existing reclaimed windows to make barn secure

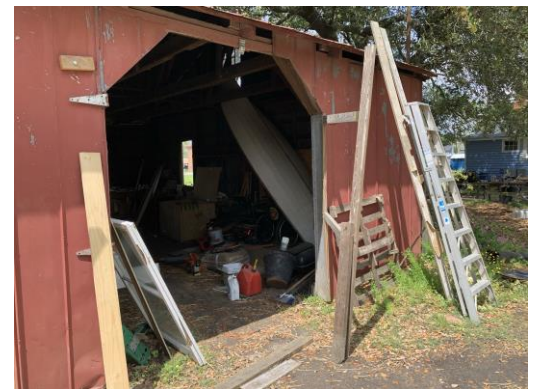
can happen with the facility, addressing this is paramount. The building does not currently appear to have utilities (power, water, sewer, etc.).

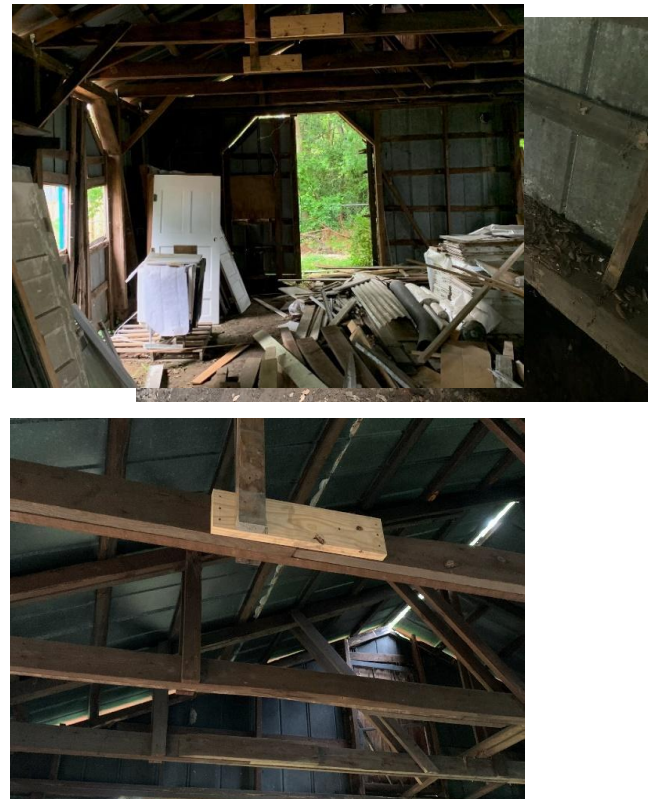
- Construct an internal frame made of 2x4s 10 ft high around the internal perimeter of the barn and attached to existing structure
- Attach 2x4 interior frame to concrete floor

- Build a secure self-contained woodworking, arts and crafts space by erecting a divider – combination of a permanent partition, portable divider and door. The space would contain workstations, power and necessary equipment to support activities and storage

- Build an attached self-contained vegetable growing area
- Construct an interior corral for garden equipment
- Build a storage container for reclaimed and recycled wood.

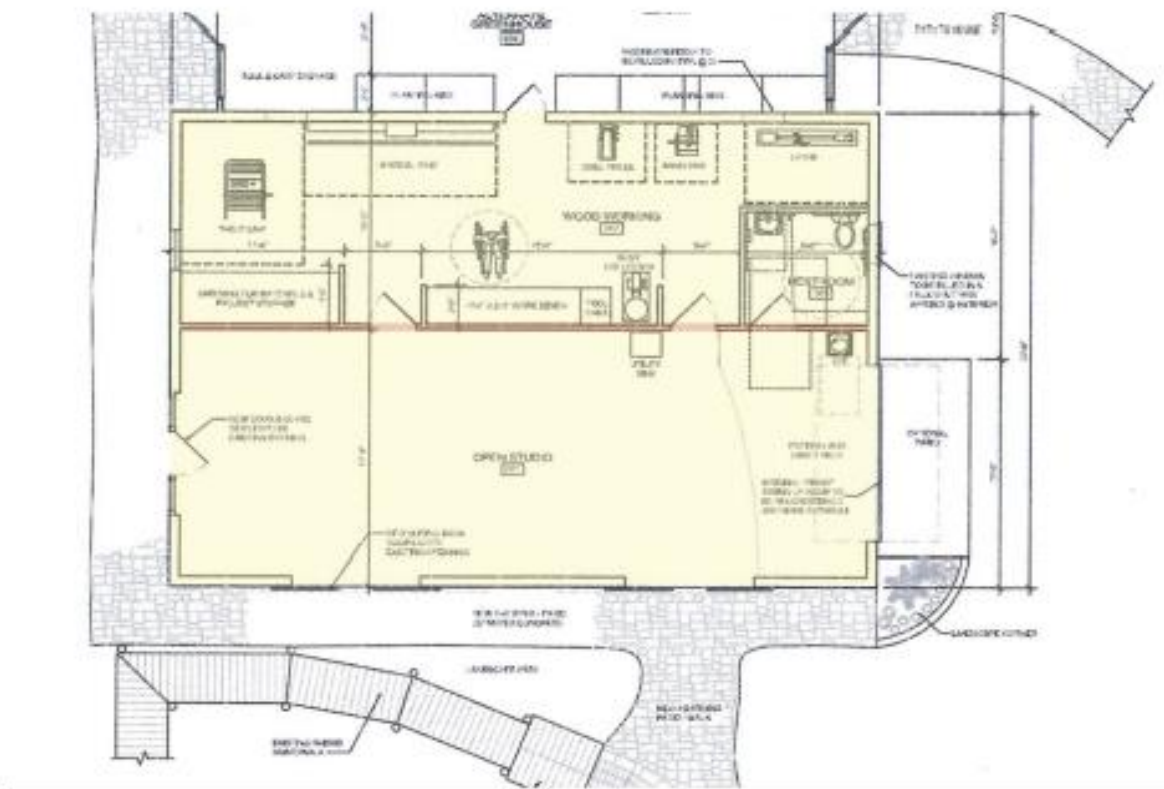
Post-frame construction, as found in “pole” barns, allows the enclosure of large areas, necessary for the intended multifaceted uses of this barn. An open-floor design offers a welcoming and undivided space without the interruption of walls limiting or working against the social construction of community, an important protective factor in at-risk women Veterans. In the woodworking area, there will be a need for walls and securable entrance for safety to those in and outside of the working area and for the security of tools, however glass or other transparent material will make up some of the interior-looking wall. If there is a need to create smaller and more intimate spaces, temporary walls on wheels will afford that need.

The roof is in need of replacement and proposed is a tin covering similar to the existing roof. The barn sides are a mixture of good, fair and poor states and to meet this more dynamic condition, repair/replacement of tin in situ is also proposed. When PRI purchased the property, there is a supply of similarly-aged tin and new tin that can be used in the renovation, if the supply is tapped out, new tin can be purchased. All repairs and replacement will follow the Historic Commission guidelines for acceptable exterior materials, the intent and actual look of the barn will convey the original design and structure itself.

The vision and intended use of the barn resists building a climate controlled “conditioned” space. In other words, retrofitting the barn to control the temperatures to a more or less constant temperature year round is problematic for several reasons. Any attempt to install an HVAC will modify the exterior and since the exterior design is a simple post-frame
